ELISHA JONES HOUSE AND SHED

HISTORIC STRUCTURE REPORT

Minute Man National Historical Park
Concord, Massachusetts

James J. Lee III
Architectural Conservator

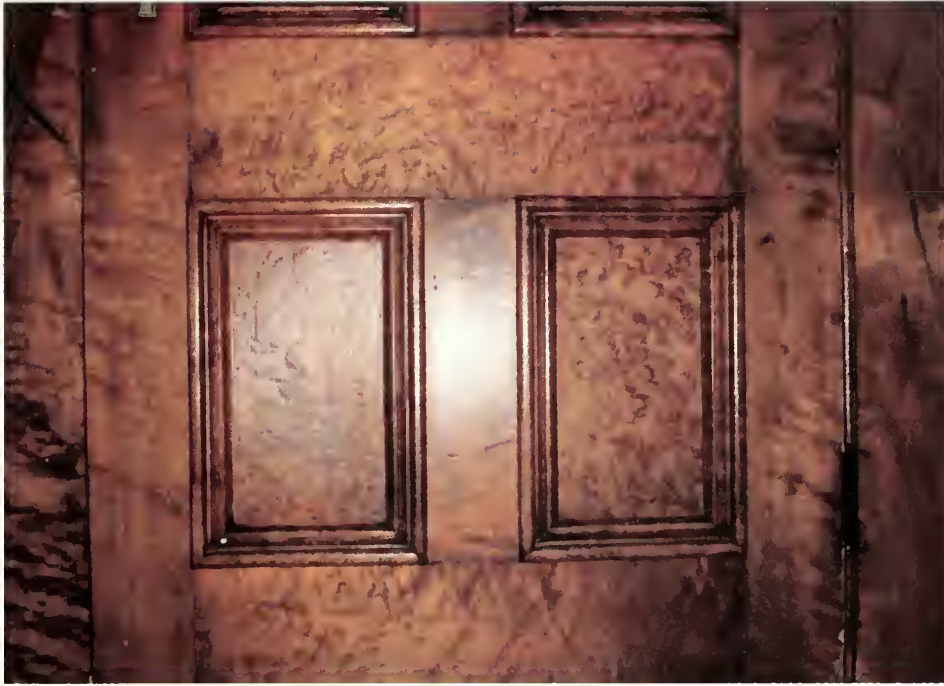
The doorway trim, window trim, and baseboards in Room 104 were constructed with plain boards, and the baseboard has a quarter- round cap. All of the woodwork, including the doors and sashes, are finished with resinous coatings. Interestingly, Room 104 and the north entry hallway (Room 107) appear to be among the few spaces that retain their Keyes- period natural wood finish. This includes the doorway trim and door to the front hallway (fig. 52).

Figure 52. Elisha Jones House: Study (Room 104), “curled maple” door and trim (2006).

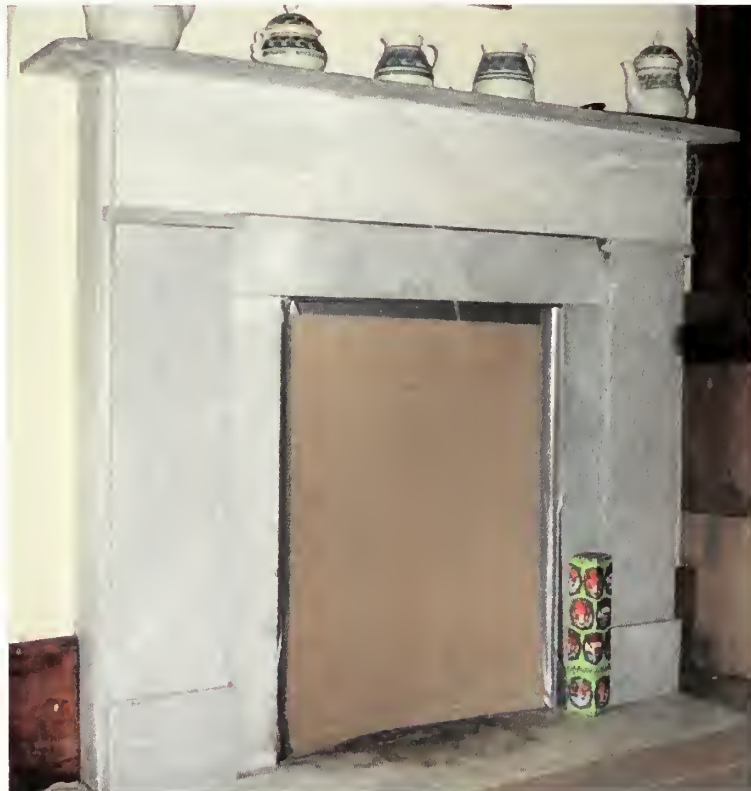
The fireplace has a white marble surround and mantelshelf, as well as a white marble hearthstone (fig. 53). The marble surround is constructed with plain pilasters supporting an unadorned frieze that supports the mantelshelf. The marble surround and mantel are typical of the Keyes- period fireplace elements, which are also found in Rooms 203 and 211. Room 104 is lighted by two wall sconces installed above the fireplace mantel.

Figure 53. Elisha Jones House: Study (Room 104), marble fireplace surround and mantelshelf (2006).

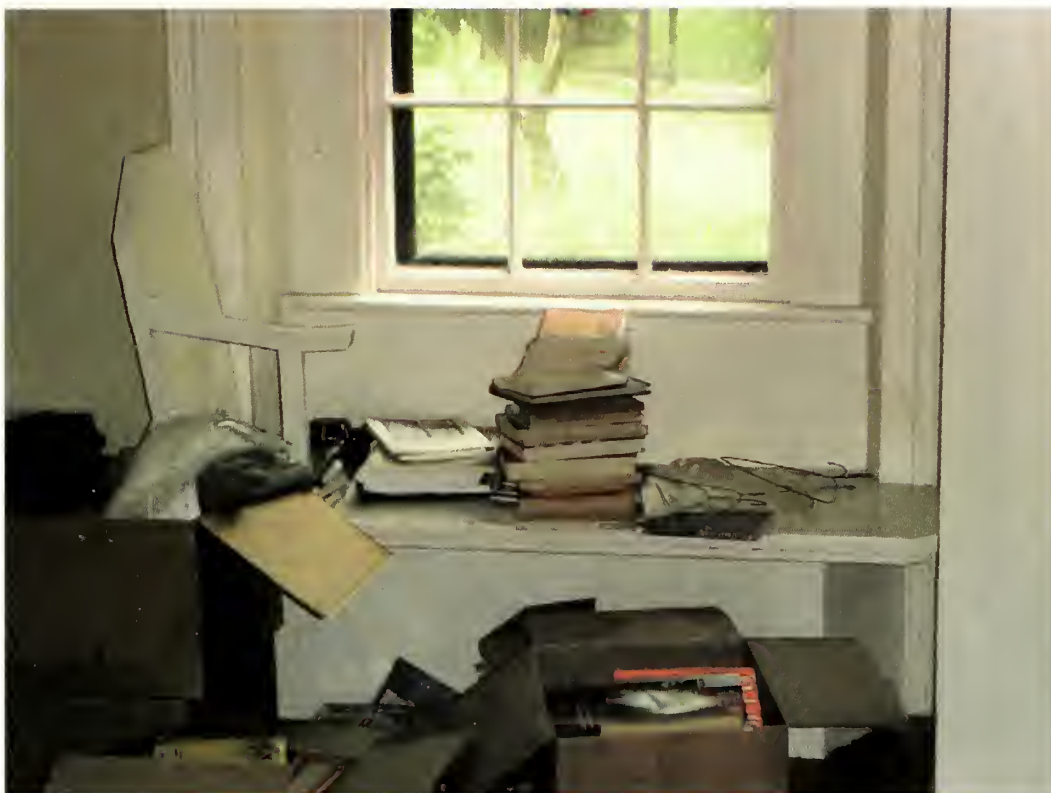
Along the south wall are a built-in closet and a built-in wooden window seat (fig. 60). The closet (204b) is in the southwest corner of the room, and is very similar to the southwest closet (203b) in Room 203, having a single four-panel door. The built-in window seat is in front of the south window (W207), and was built with an angled back and a curved arm rest. Paint samples taken from both the seat and the closet indicate that they were installed after the Keyes- period renovations. A comparison of the number of paint layers in the paint samples further indicate that the window seat was installed before the closet. These features appear to date from the late- 19th to early 20th century.

Figure 60. Elisha Jones House: Southeast bedroom (Room 204), window seat (2006).

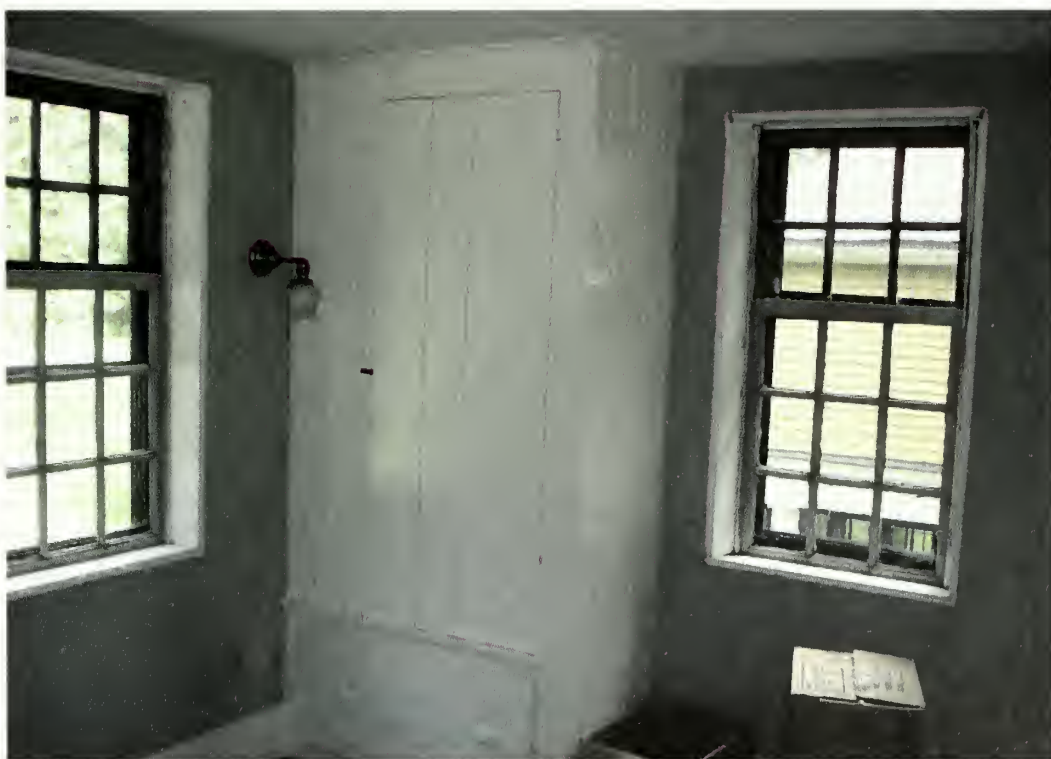
Room 208 has windows on the south, east, and west elevations. As explained previously, the windows on the south and east elevations (W217 and W218: figure 61) are pre- Keyes in date. Window 217 may well be in its original location; window W218 was probably moved here by Keyes from the main house. The windows have splayed jambs and a narrow sill that are flush with the plaster wall, but no other trim. The sashes of the west- wall window (W227), adjacent

Figure 61. Elisha Jones House: Room 208, corner closet, and east- and south- wall windows (2006).
